Springfield Land Clearance for Redevelopment Authority

This Blight Report for the Mount Vernon and Market Redevelopment Area (this “Blight Report”) is being submitted by WPV, LLC, a Missouri limited liability company (the “Developer”), for the purpose of demonstrating that the Redevelopment Area (as defined below) should be declared blighted pursuant to the LCRA Law. This Blight Report will demonstrate that the Development Area (as hereinafter defined) is a “blighted area” under the LCRA Law due to the predominance of (1) deterioration of site improvements; (2) insanitary and unsafe conditions; and (3) the existence of conditions which endanger life and property by fire or other causes. Because of the aforementioned conditions, the Redevelopment Area constitutes an economic and social liability and a menace to the public health, safety, morals, and welfare in its present condition and use.

Property Inspection Report

616 S. Market, Springfield, MO
Inspection prepared for: Phil Wienke
Real Estate Agent: N/A -

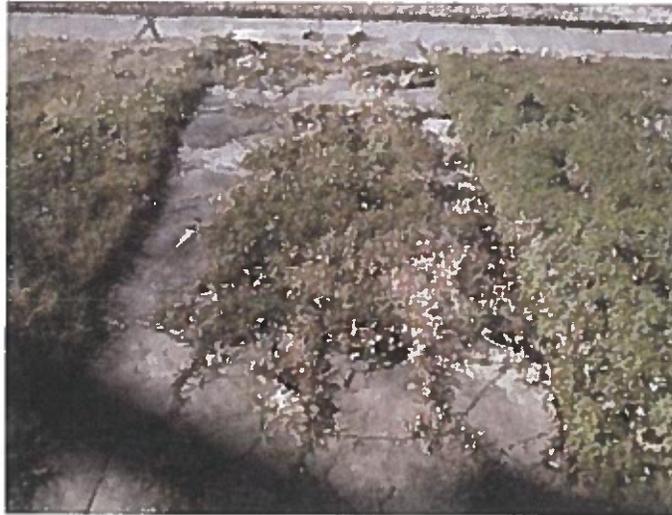
- Sidewalk is badly damaged & deteriorated. Needs complete replacement.

Sidewalk is badly damaged & deteriorated

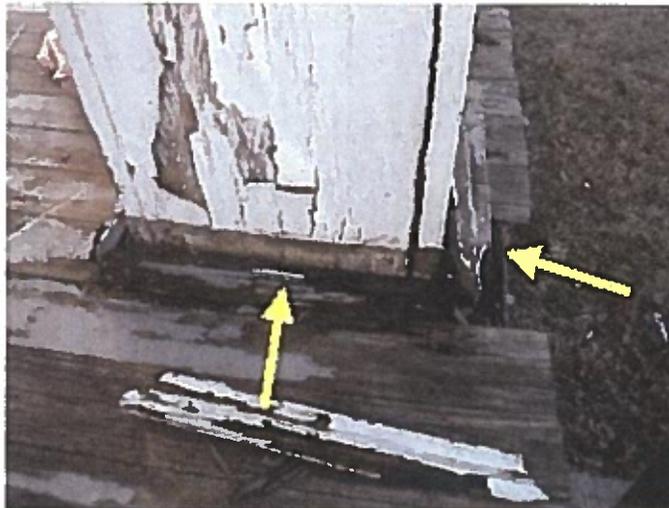
- Moisture damage found around base of several posts. Needs attention/repair.

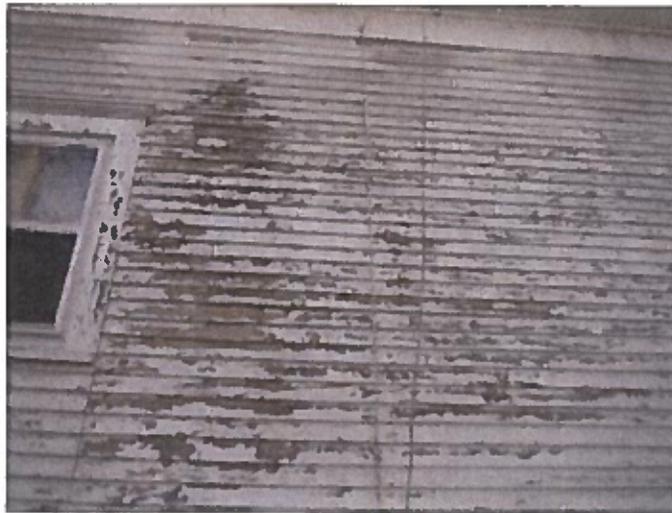
- Areas of damaged and poorly patched siding at NE corner.
- Heavy peeling paint on most all of exterior siding. Paint may be lead. Needs remediation by a qualified contractor.

Heavy peeling paint on all sides of exterior

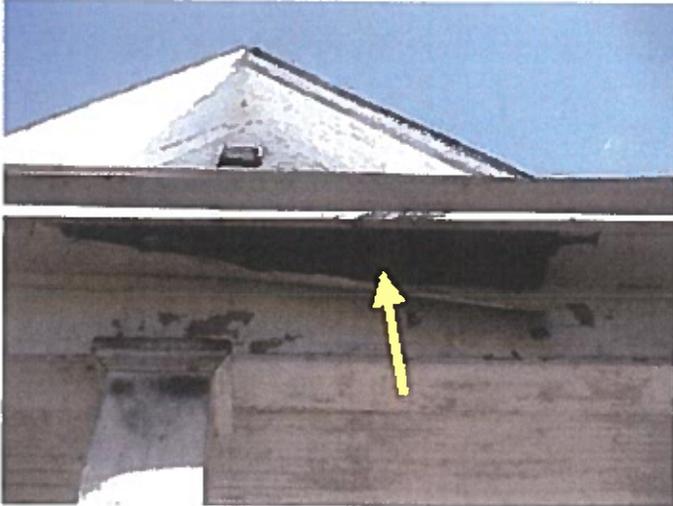
Moisture damaged soffit at front porch

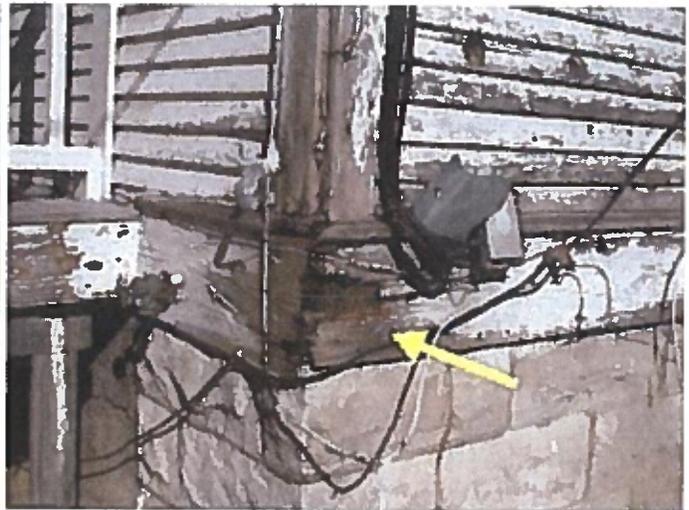
Moisture damage at lower SW corner

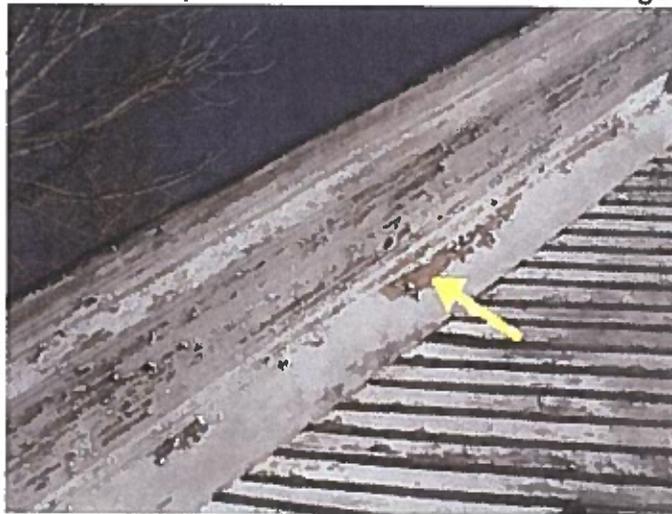
Suspected lead based peeling paint on all soffit, fascia, and trim

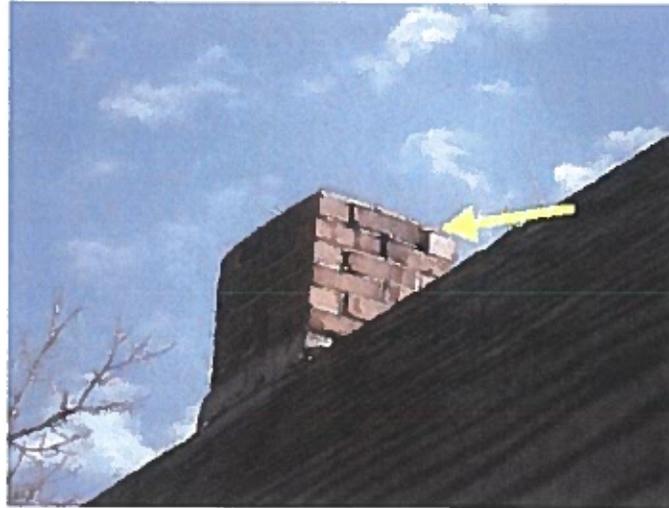
- Rain cap/spark screen recommended
- FYI: Chimney is the flue for the water heater and furnace.
- Areas of missing mortar observed at top of chimney. Needs tuck pointing by mason.

Areas of missing mortar observed at top of chimney

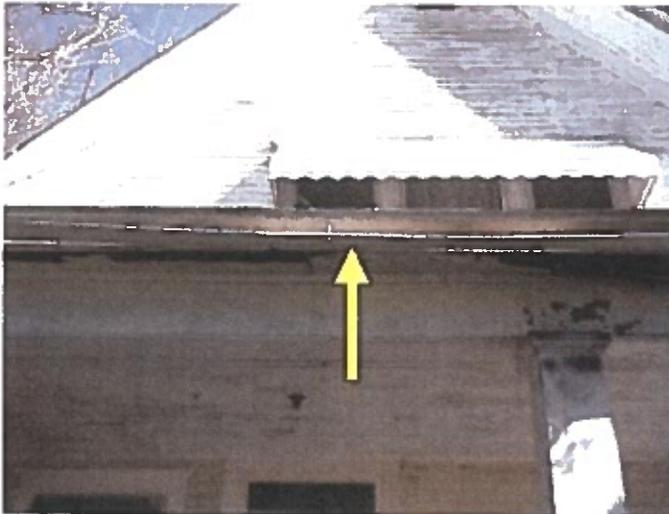
Guttering at front porch is loose/displaced

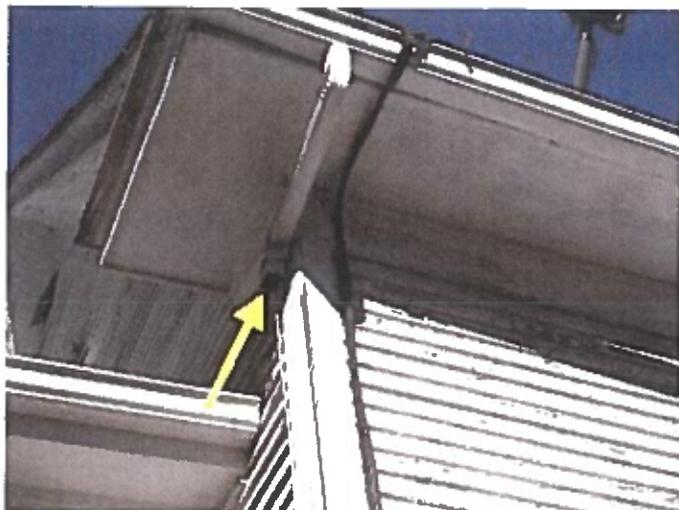
Missing downspout at SW corner

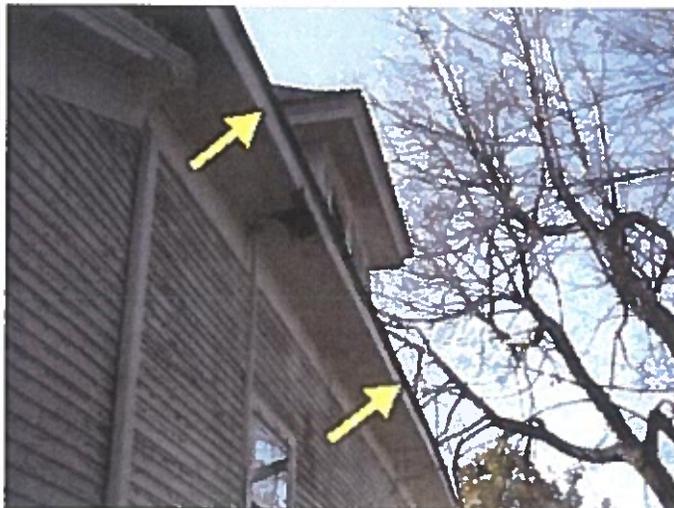
No guttering is installed on the north side

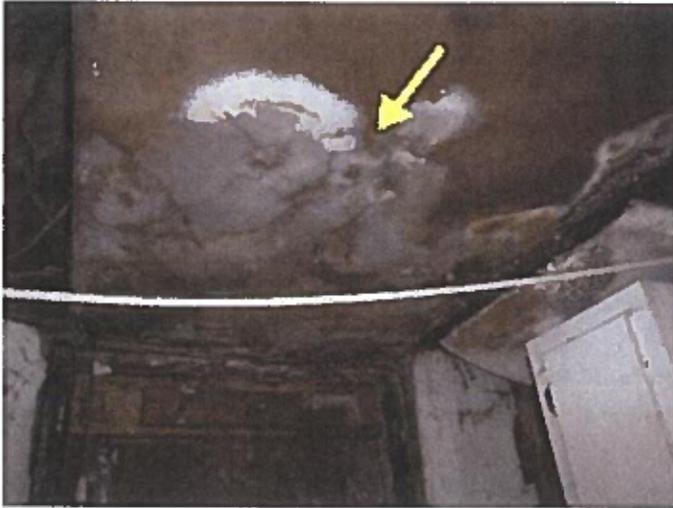
Mold growth on ceiling at SE room in basement

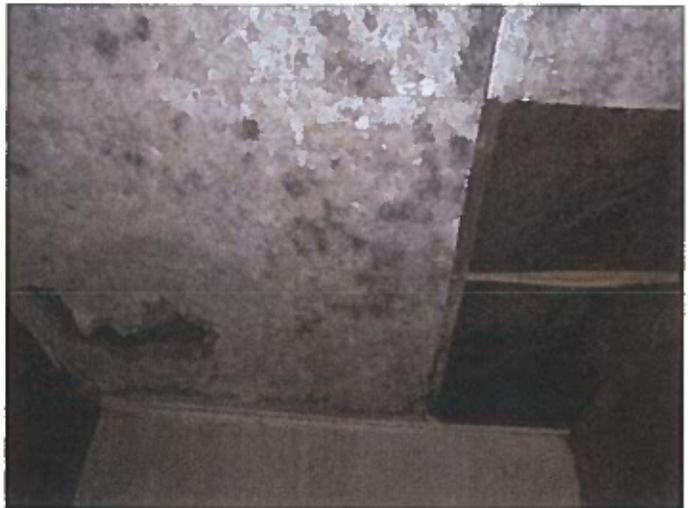
Mold/fungal growth on ceiling at middle east part of basement

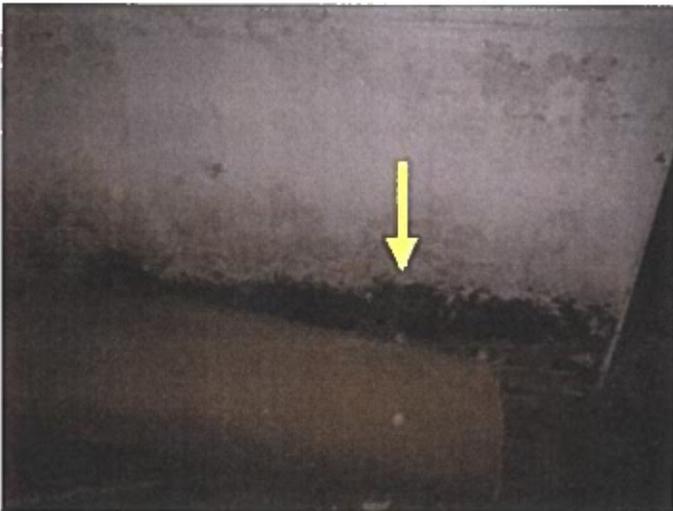
Black mold on base of wall at NE basement room

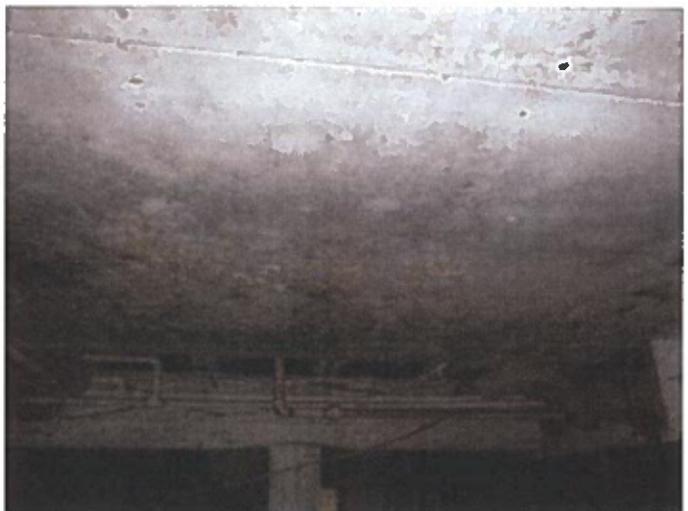
Fungal growth on ceiling in middle part of basement

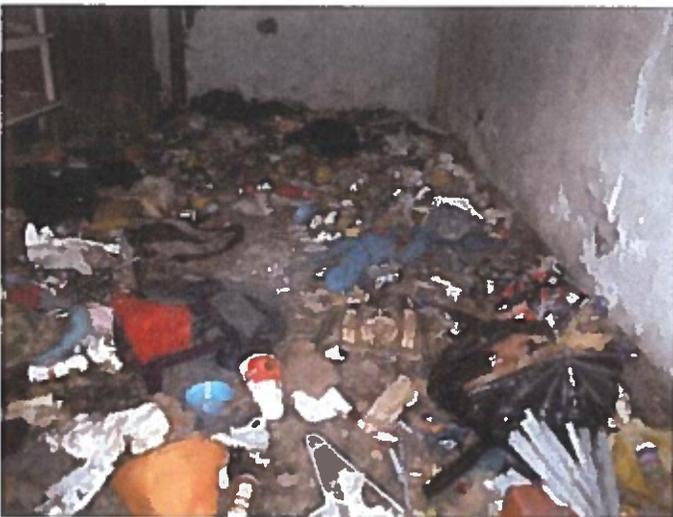
Trash and debris at west room in basement

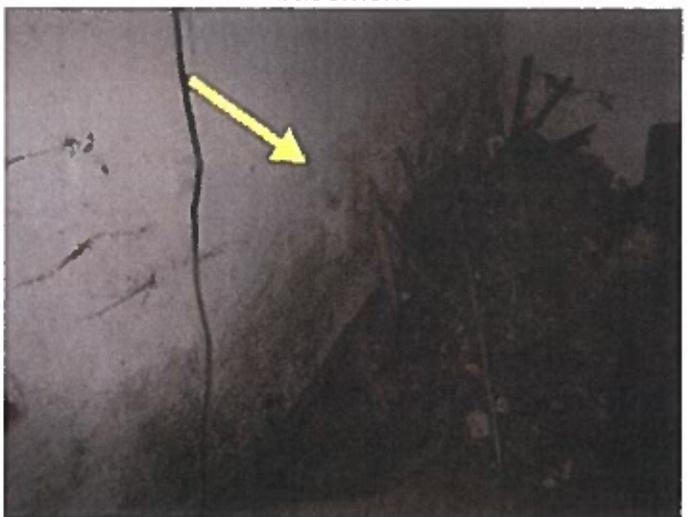
Insulation and debris at NE corner of basement

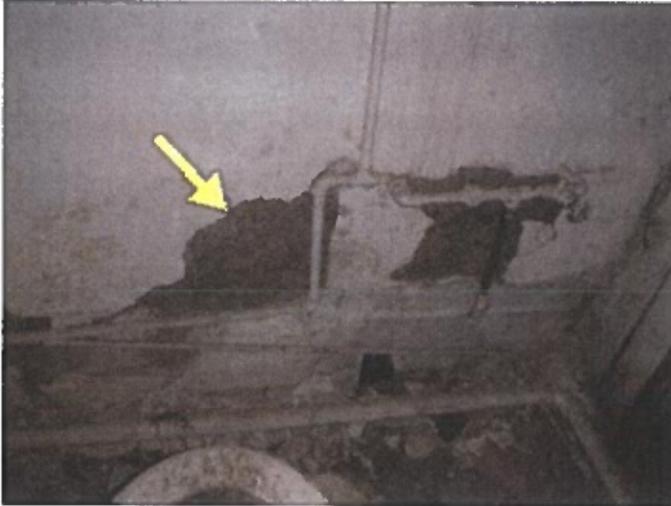
Evidence of past water penetration at south foundation wall and main water line

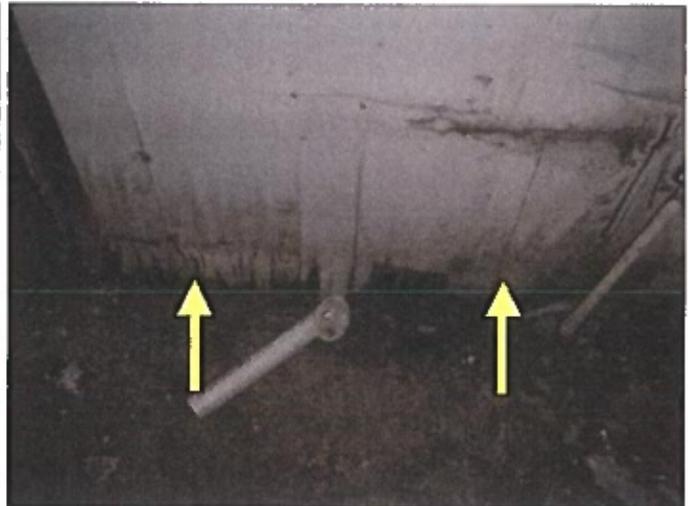
Water damaged wall at basement bathroom area

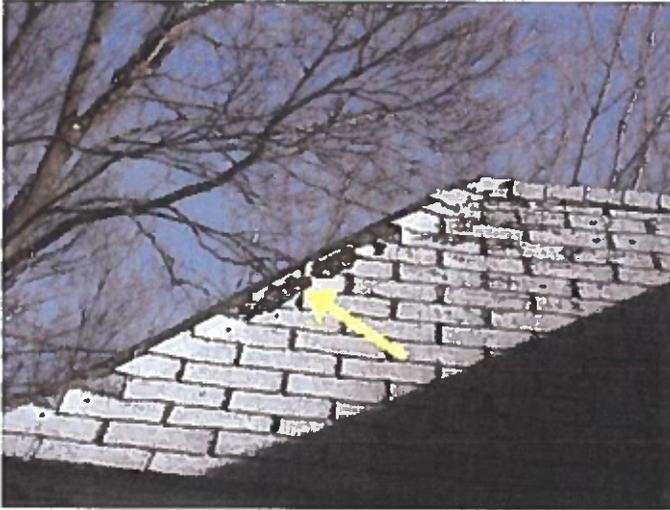
Missing hip shingles at NW corner

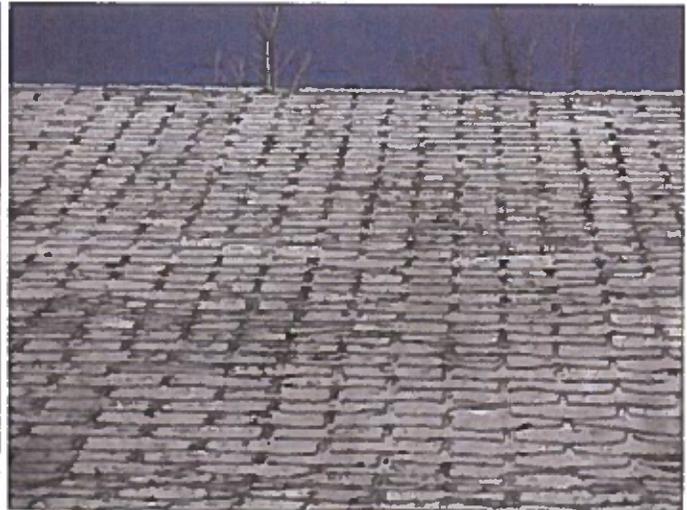
Shingles are beyond the end of their normal life

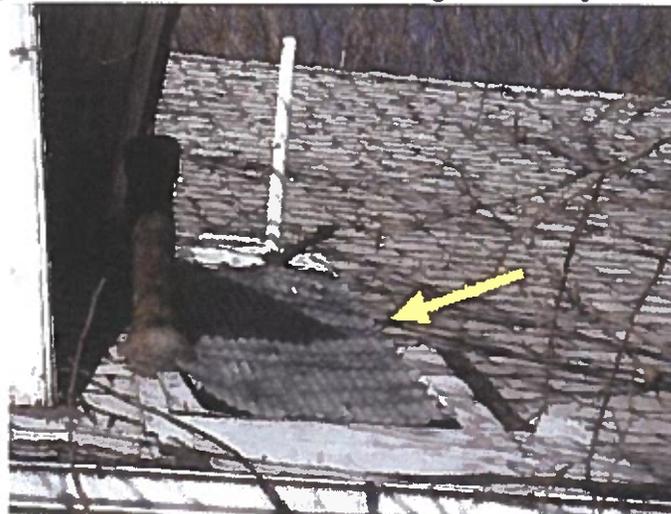
Inadequate repair to south field just east of dormer

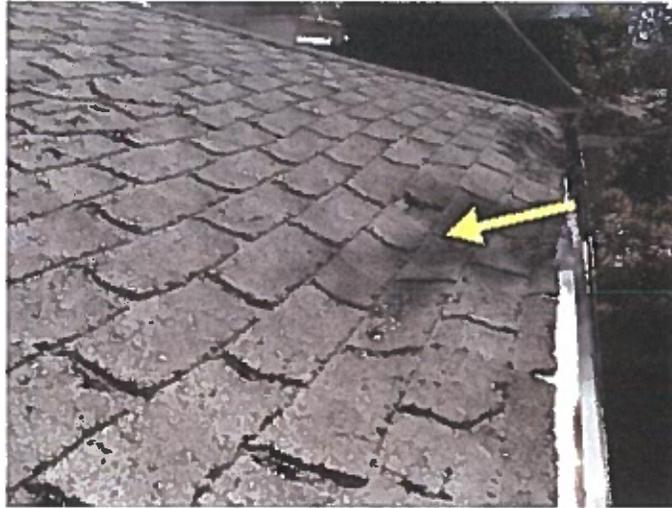
- The porch roof is actively leaking and has an area of moisture damaged decking at front middle edge. Needs repair by a qualified roofer.

Moisture damaged decking from active leakage and deteriorated shingles

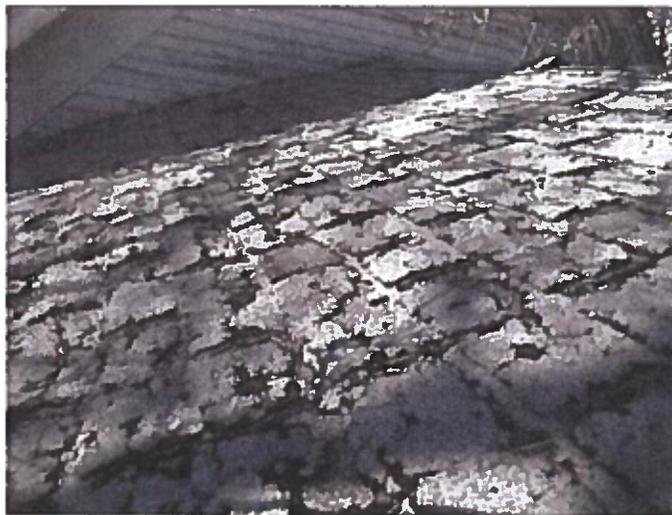
- Shingles on back addition are beyond their normal life and in need of complete replacement.

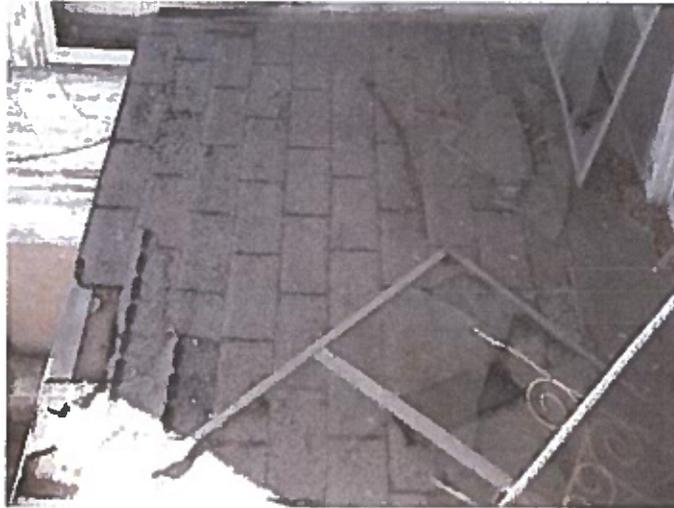
- Shingles are improperly installed on a flat surface. Needs replacement with the proper type of material for low/flat surfaces.

Shingles are improperly installed on a flat surface above the basement entry

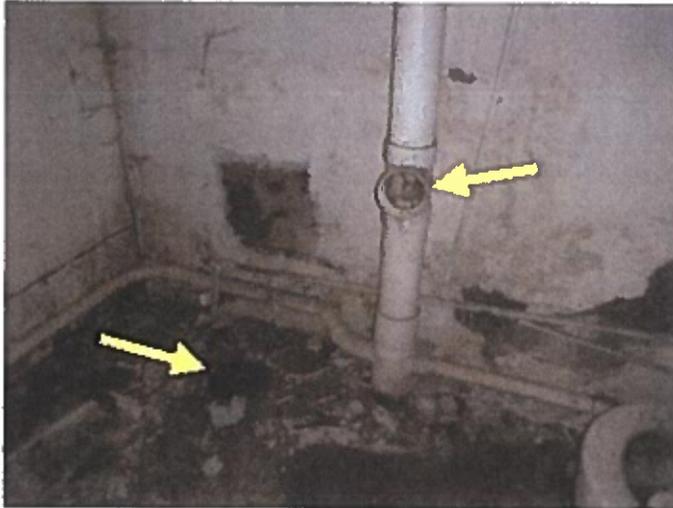
Open sewer lines at basement bathroom

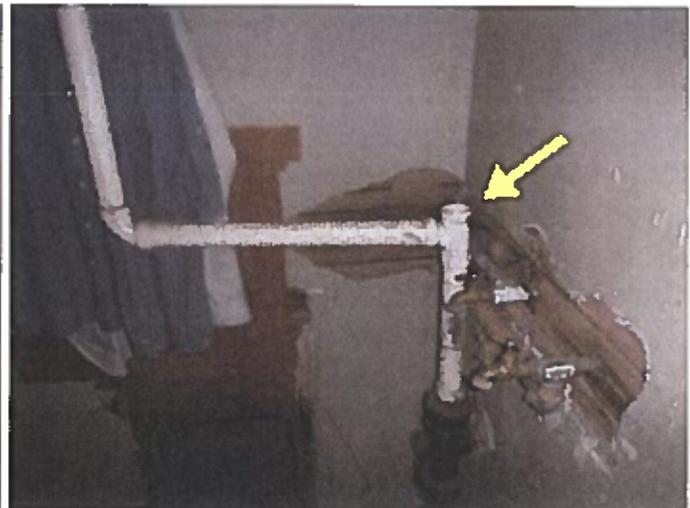
Improper open drain pipe at upstairs laundry area

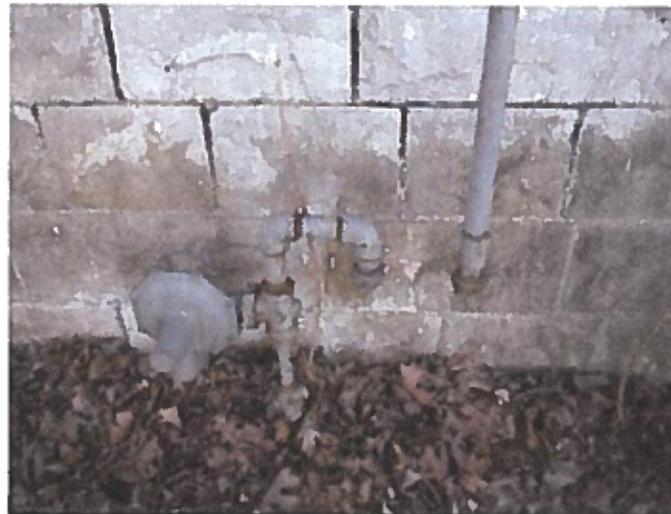
- **Home had no gas at time of inspection; meter was missing on north side.**

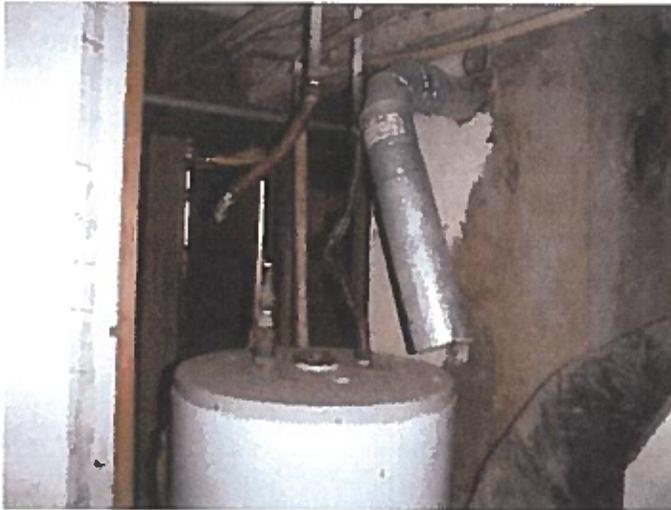
- Combustion air is adequate
- TPR valve installed on tank
- Water heater had cut supply lines, gas line, and displaced flue pipe. Needs repair by a qualified plumber.

Water heater flue is displaced from heater

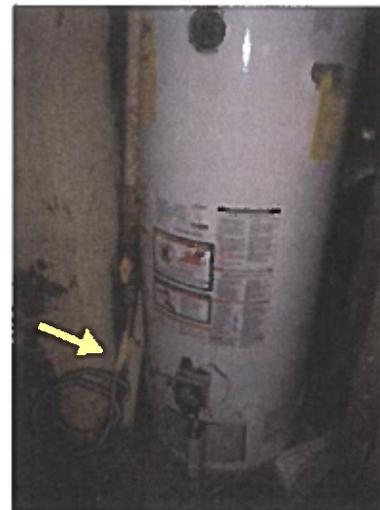
Gas line was cut/disconnected

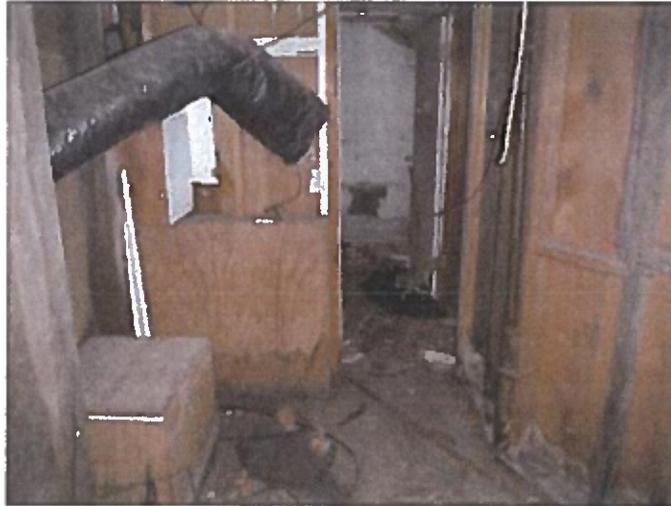
- Furnace appears to have been stolen; missing at time of inspection. Needs complete replacement by an HVAC technician.

Furnace appears to have been stolen; missing at time of inspection

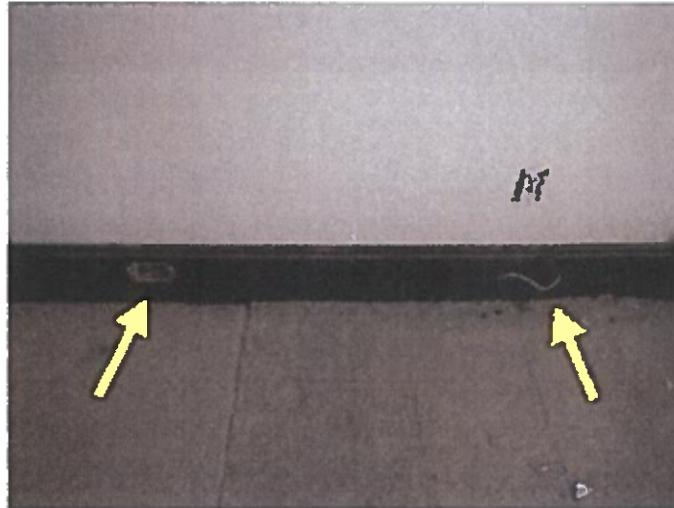
- No power; unable to test
- Baseboard heaters were missing in upstairs bedroom and bath.

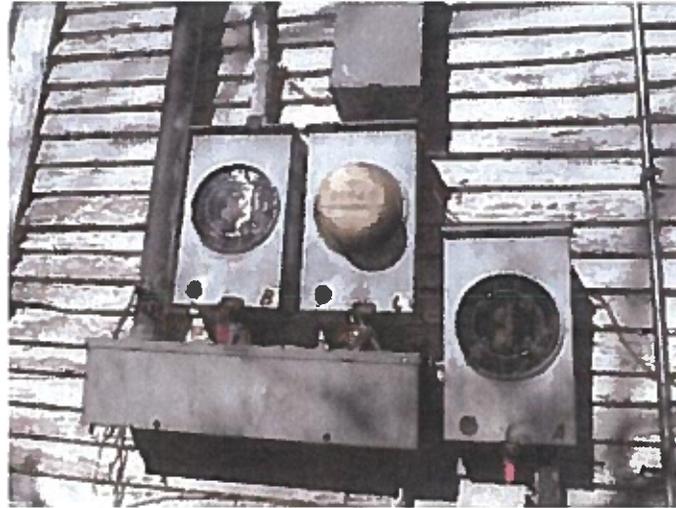
Electric service was off at time of inspection

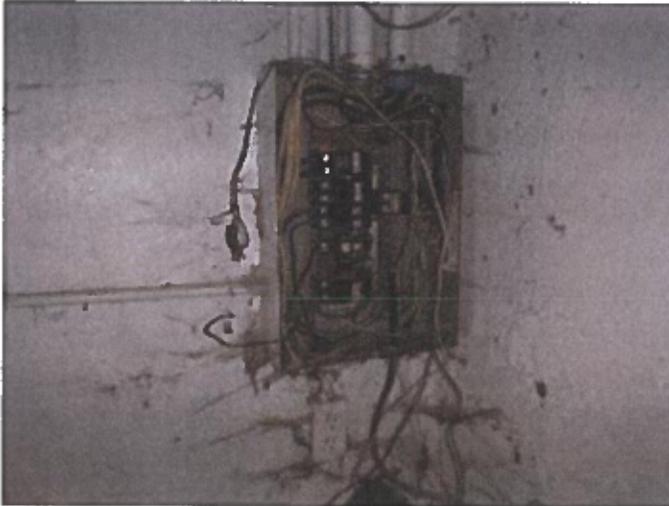
Exposed wiring and missing cover at panel in basement

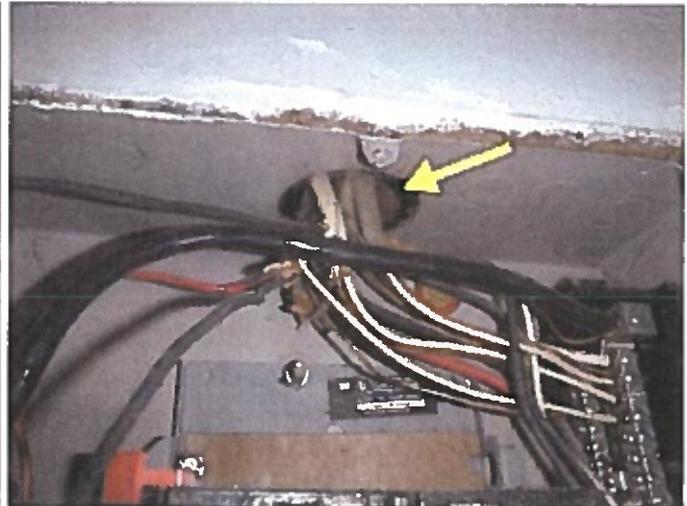
All wires enter upstairs panel without bushings/wire clamps

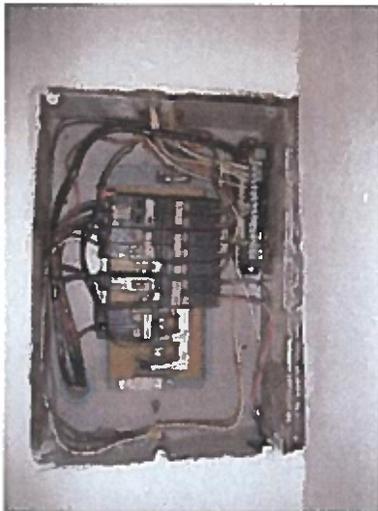
Upstairs panel cover was missing and all wires enter panel without bushings

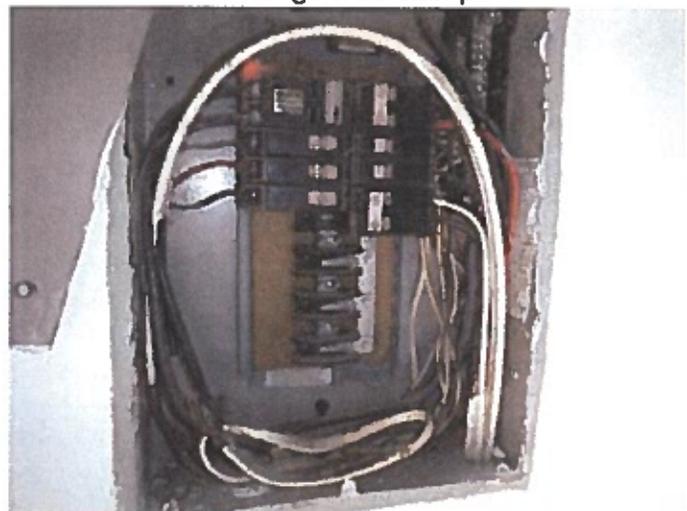
Improper wiring inside main level panel

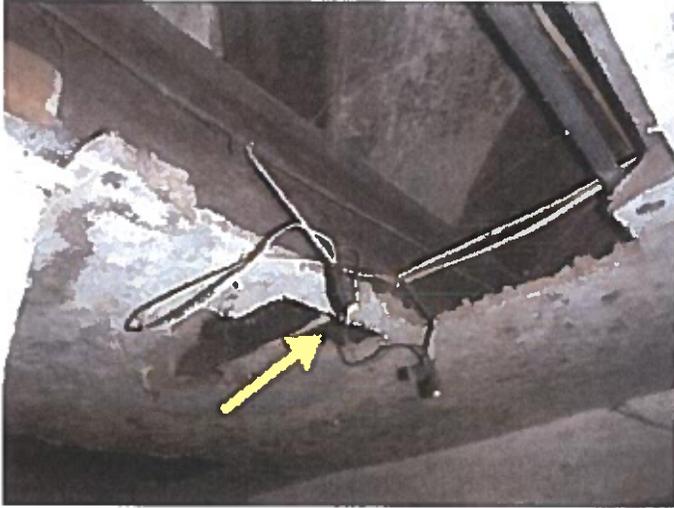
ungrounded system, which creates a risk of electrical shock or fire. Today, this system is considered obsolete and can be a safety hazard, especially when improper modifications are made to the wiring. Due to the risk of fire associated with knob and tube wiring, many insurance companies will not insure houses containing this type of wiring. To fully eliminate these dangers, all of the existing knob and tub wiring must be removed and new wiring installed.

Exposed knob and tube spliced wiring at middle east part of basement

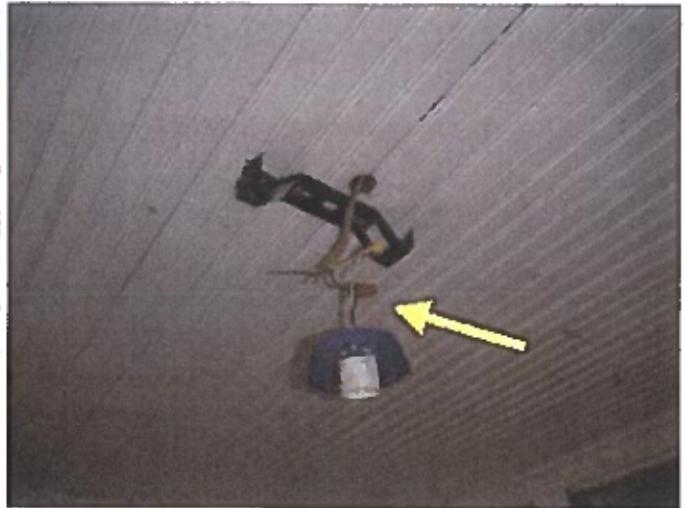
Improper fixture at rear main sunroom

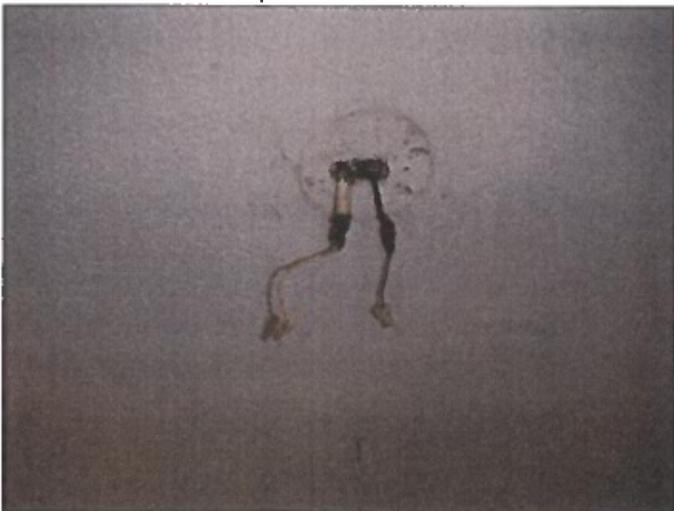
Exposed wiring from missing light fixtures at upstairs hallway/stairway

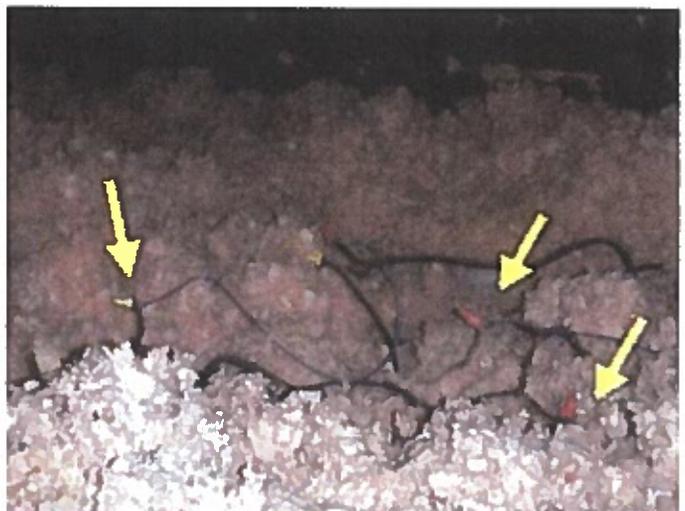
Improper exposed splices at middle west part of attic

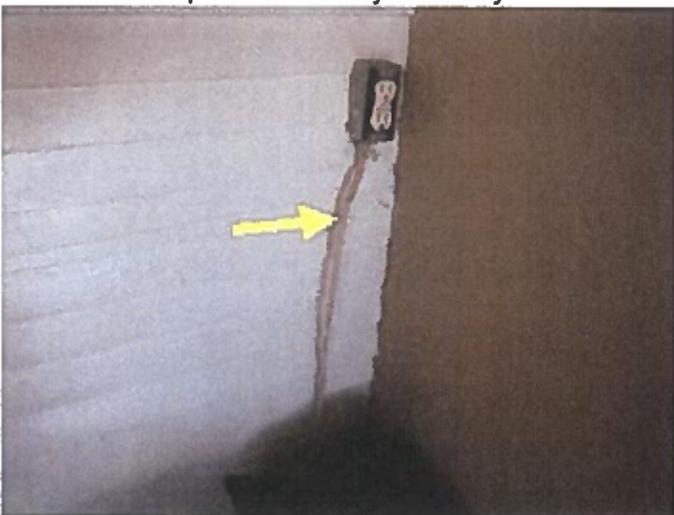
Exposed wiring and uncovered outlet at NW corner of upstairs sunroom

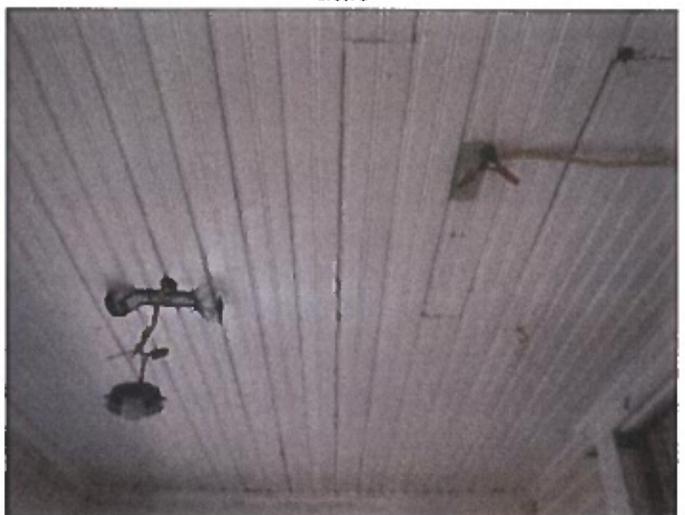
Exposed wiring at ceiling of main level sunroom

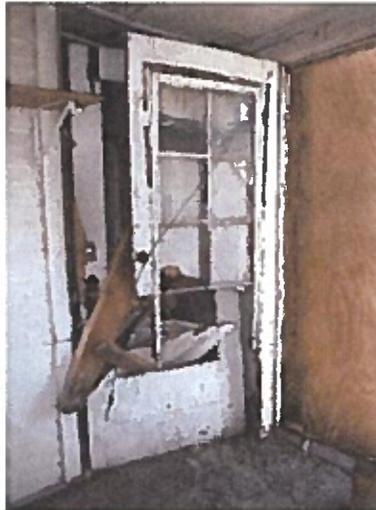
- Main level exterior door was damaged beyond repair. Needs replacement.

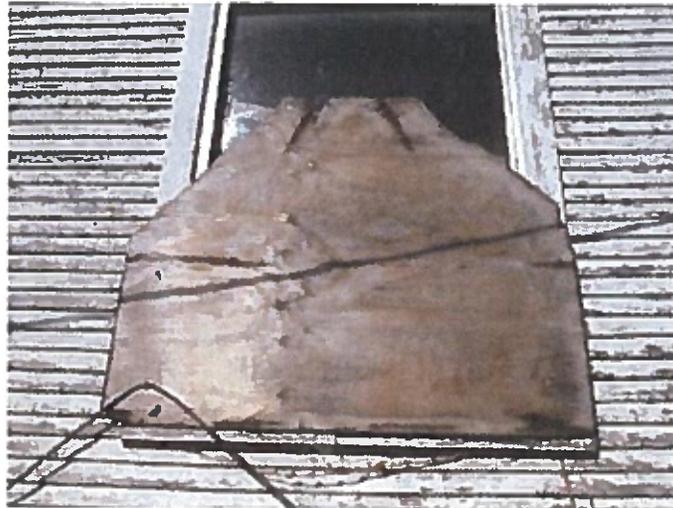
- Most every window is damaged and has broken glass. Needs repair/replacement.

Boarded up broken south living room window

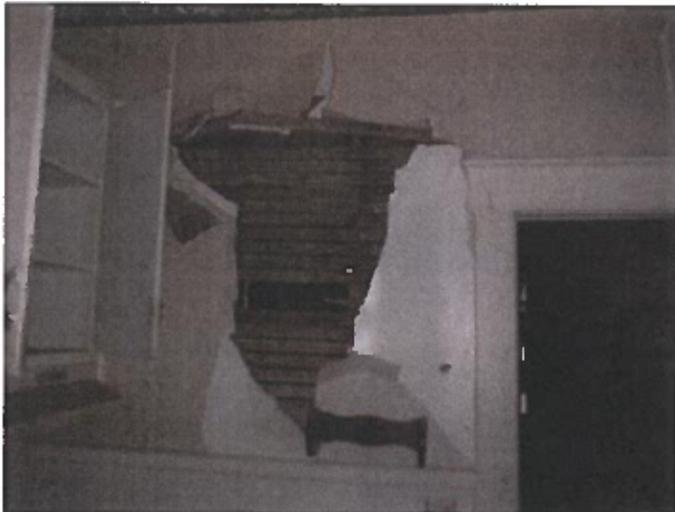
Damaged wall between kitchen and entryway

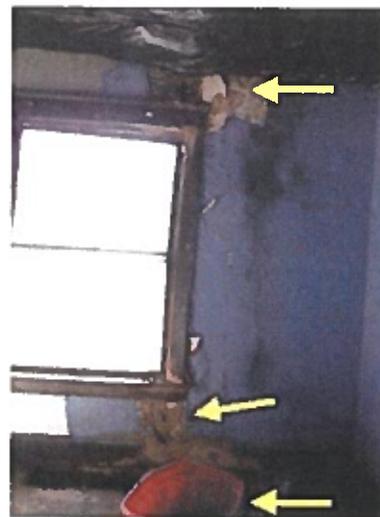
Water damaged wall from active roof leakage at SE main level bedroom

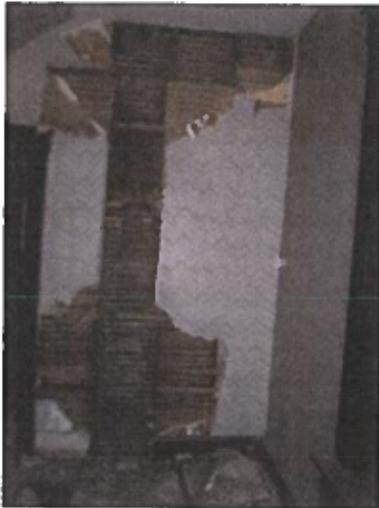
Damaged east wall in front entry

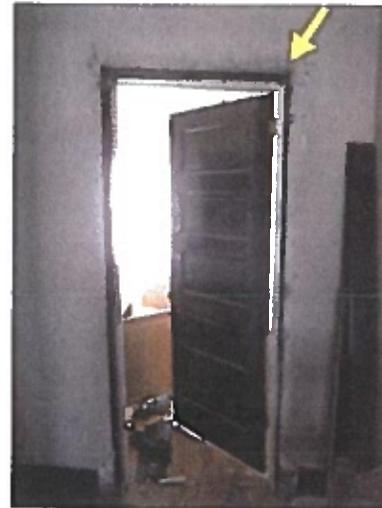
Door to the upstairs bathroom is out of plumb

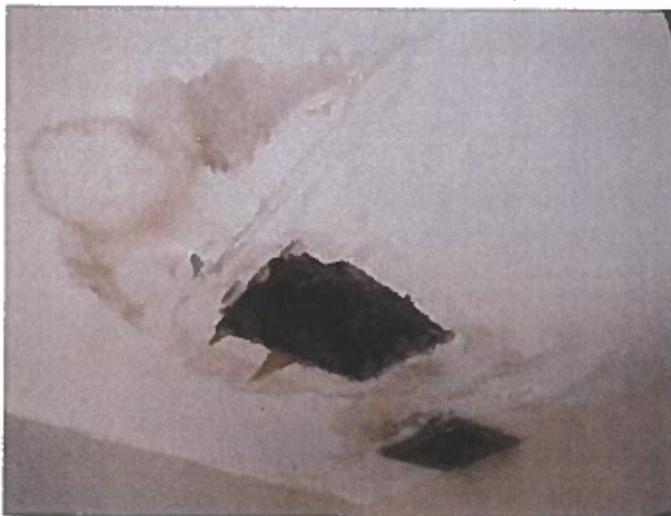
Stains and holes in ceiling in SW main level room

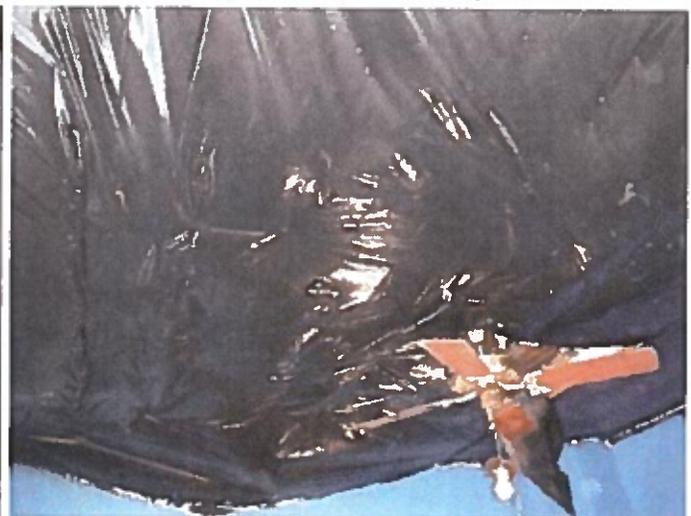
Ceiling in SE main level room is covered with plastic

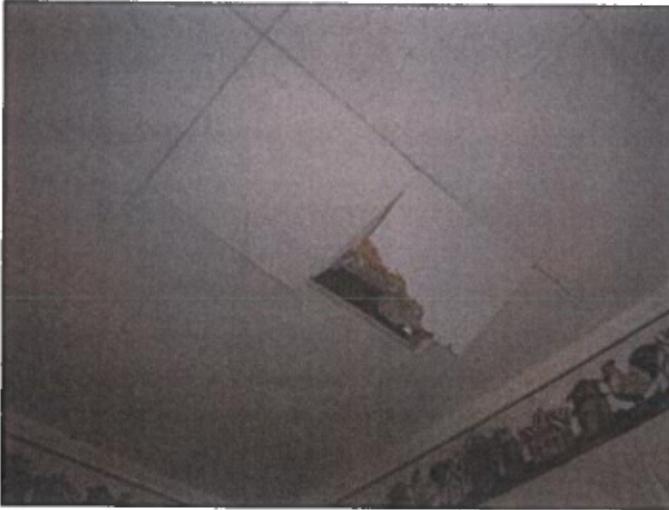
Damaged ceiling tiles at SW corner of main level kitchen

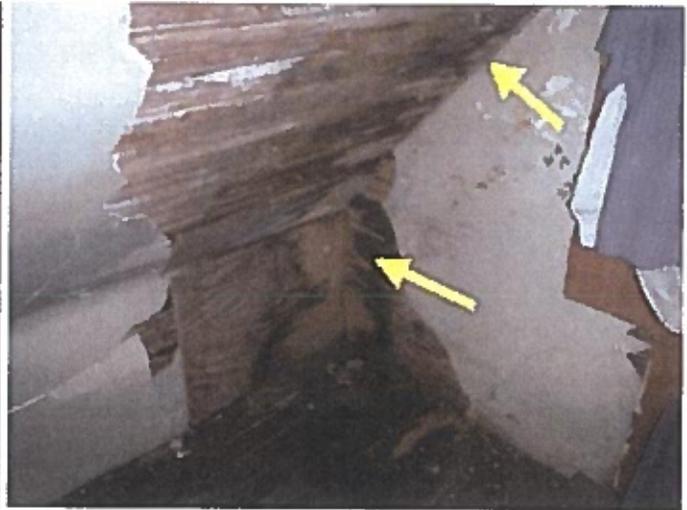
Damage from active leakage at SE upstairs closet

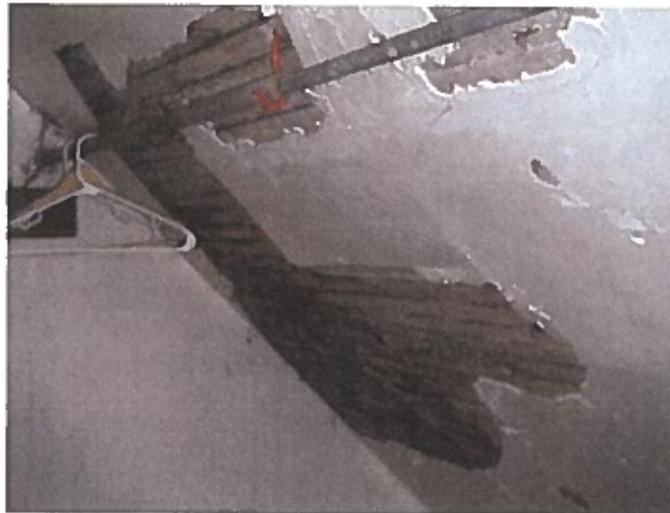
Damaged/missing plastic at upstairs SW closet

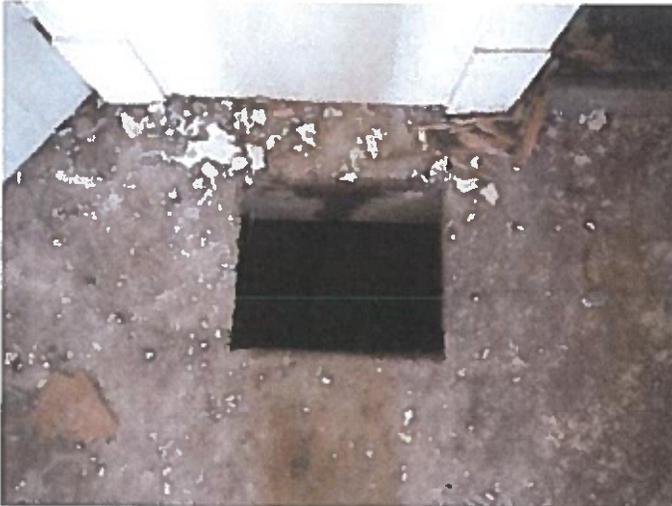
Several holes in main level flooring from lack of ductwork

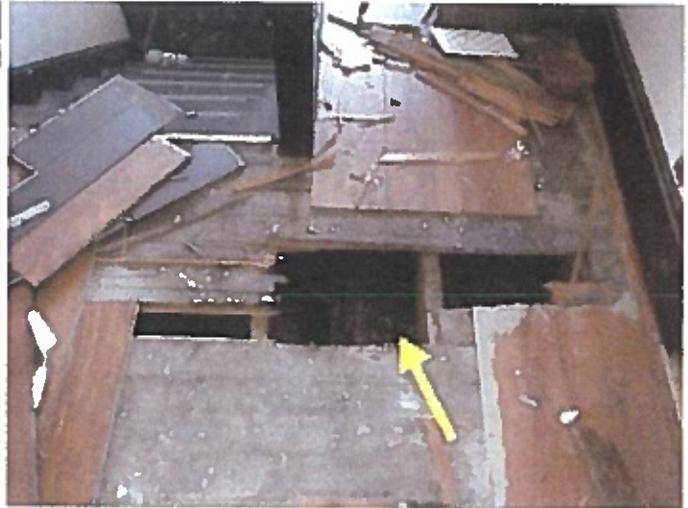
Holes in floor at upstairs hallway

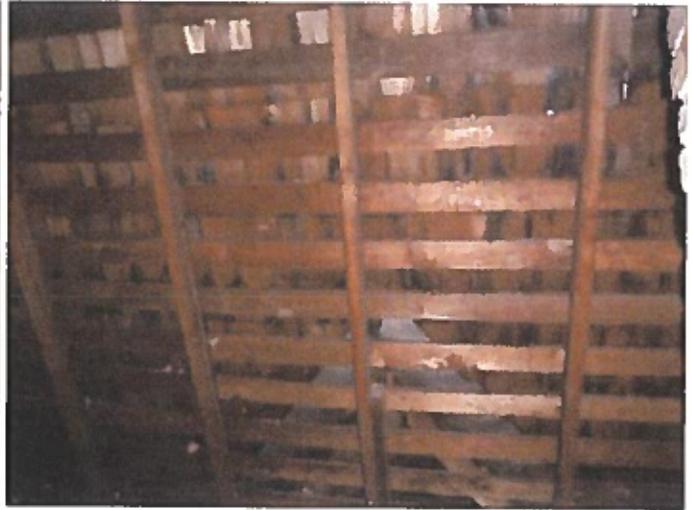
Original wood shingles are still present below two layers of comp shingles

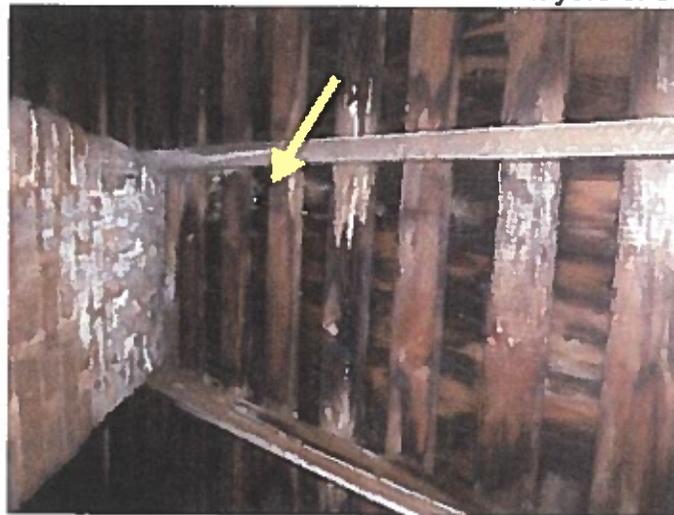
Moisture stains below chimney indicating past leakage

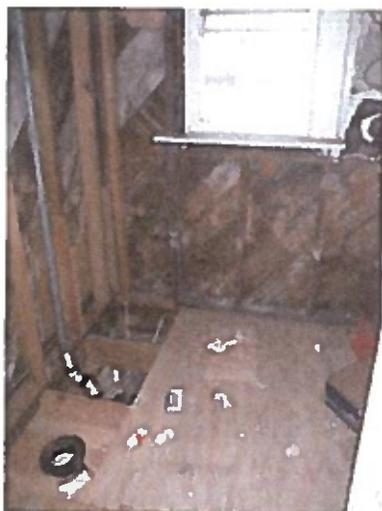
Main level NE bathroom appeared to be a work in progress

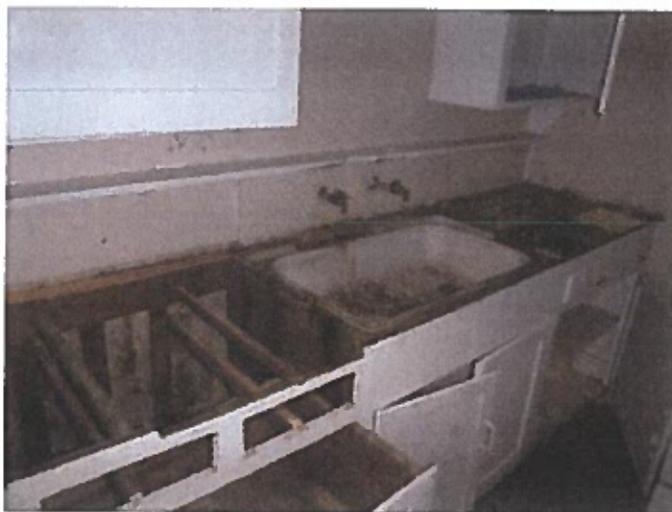
Upstairs kitchen has no countertop and is in poor condition
