Springfield Land Clearance for Redevelopment Authority

This Blight Report for the Mount Vernon and Market Redevelopment Area (this “Blight Report”) is being submitted by WPV, LLC, a Missouri limited liability company (the “Developer”), for the purpose of demonstrating that the Redevelopment Area (as defined below) should be declared blighted pursuant to the LCRA Law. This Blight Report will demonstrate that the Development Area (as hereinafter defined) is a “blighted area” under the LCRA Law due to the predominance of (1) deterioration of site improvements; (2) insanitary and unsafe conditions; and (3) the existence of conditions which endanger life and property by fire or other causes. Because of the aforementioned conditions, the Redevelopment Area constitutes an economic and social liability and a menace to the public health, safety, morals, and welfare in its present condition and use.

Property Inspection Report

616 S. Market, Springfield, MO
Inspection prepared for: Phil Wienke
Real Estate Agent: N/A -

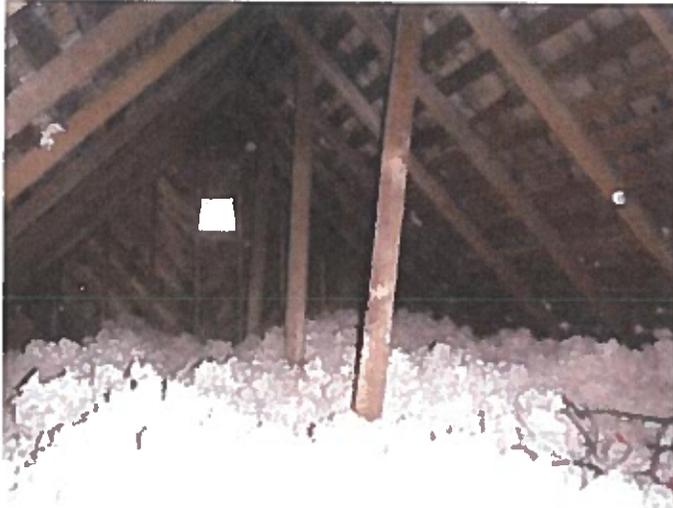
Partial view in middle of attic looking west

- Appears serviceable
- Entered
- Minimal ventilation provided
- Roof decking still consists of the original cedar shingles.
- Moisture stains and signs of past leakage at south side of chimney.
